**DECLARATION OF BRAD A.  
JAMES**

1. Exponent was retained by counsel for Tyco Fire Products, LP, to analyze the physical evidence and review pertinent documents related to the rupture of the fire suppression test tank that occurred on February 12, 2016, at Oprandy's Fire and Safety Equipment, Inc., in Middletown, New York.

2. In connection with Exponent's investigation, I provided a report entitled "Buono v. Poseidon Air Systems et al., Metallurgical Investigation" on April 16, 2020. A true and correct copy of my report is attached hereto as Exhibit A.

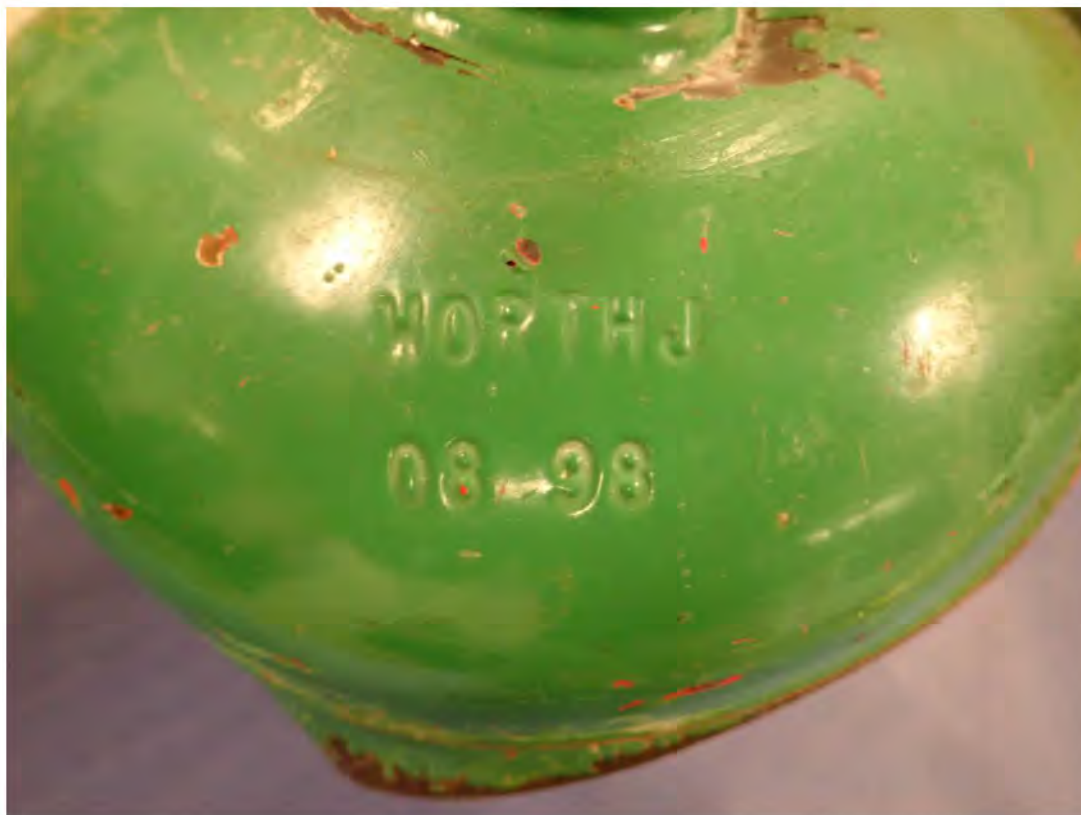
Figure 2. A photograph of the subject cylinder showing the markings "WORTH J 08-98"

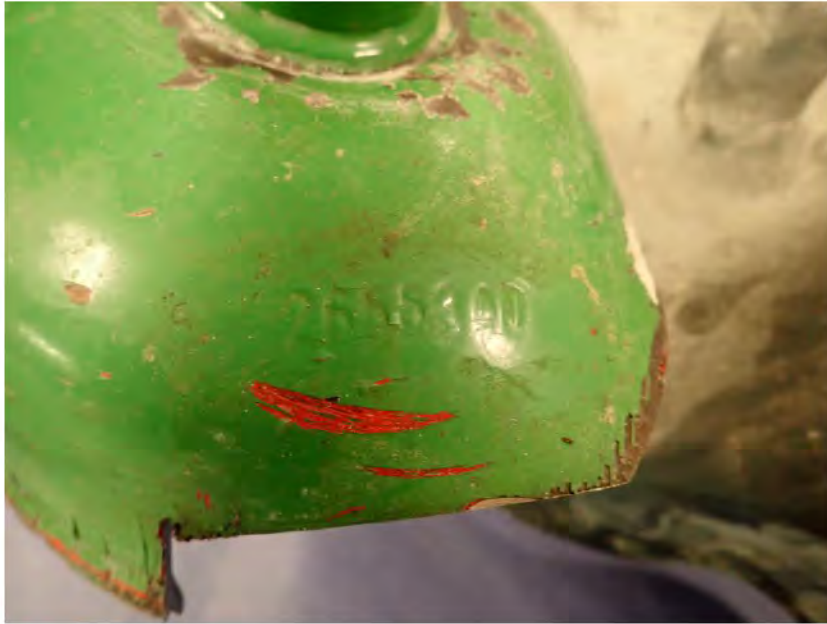
Figure 3. A photograph of the subject cylinder showing the markings "26553AD"

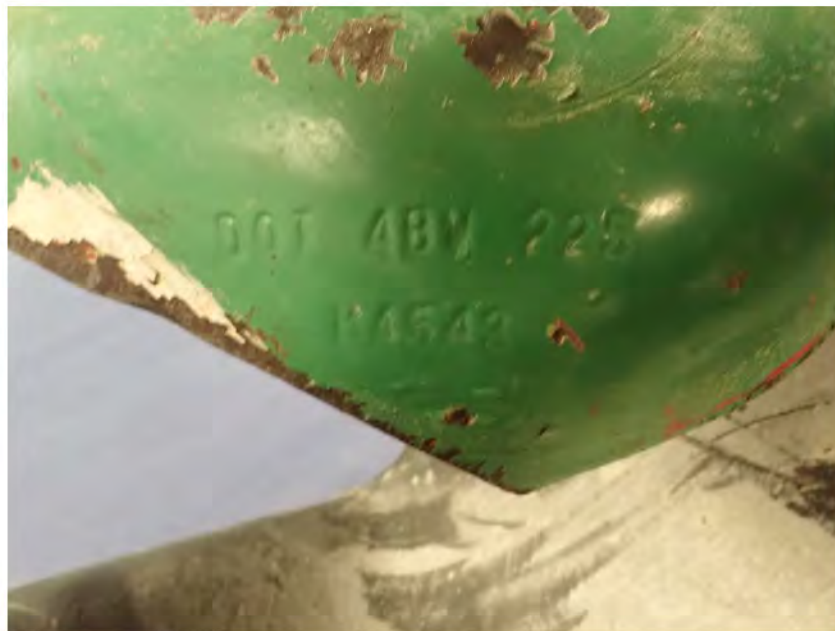
As part of the rupture event, the subject cylinder was separated into two fragments (as shown in Figure 1 of the May 5, 2016 OSHA report). Subsequent testing by OSHA included cutting small samples for fractographic analysis and hardness testing. Markings present on the top of the subject cylinder cap were: “WORTHJ 08-98”, “26553AD”, and “DOT 4BW 225 M4543”, as shown in Figure 2 through Figure 4. These markings indicate that the cylinder was manufactured by Worthington Industries in August 1998, that the cylinder was manufactured in accordance with DOT 4BW, and rated for pressures up to 225 psi. The cylinder wall thickness

measured between approximately 0.073 and 0.084 inches, depending on the location of measurement. The cylinder diameter was approximately eight inches.

Figure 4. A photograph of the subject cylinder showing the markings "DOT 4BW 225 M4543"

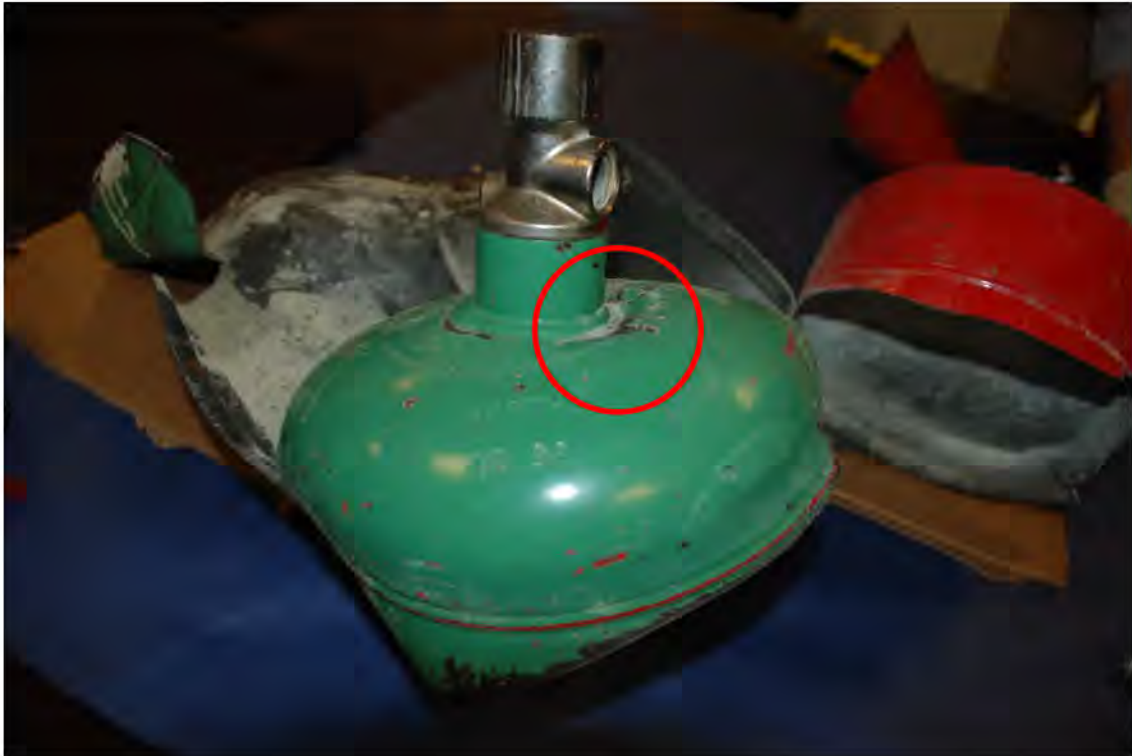
The top cylinder cap was deformed inward at the location at the base of the valve assembly, as shown in Figure 6. This deformation is consistent with an outside force acting in an inward direction at the valve/ pipe fitting assembly. This force was likely the result of the valve/fitting assembly impacting another hard object after the initial overpressure-induced failure. The fractured fitting is discussed in the following section.

Figure 6. A photograph of the valve/fitting assembly and cylinder cap. Inward deformation of the cylinder cap (circled) was caused by external loading applied to the valve/fitting assembly.

The macroscopic and microscopic fracture surface features observed on the threaded pipe fitting, as well as the inward plastic deformation of the top of the tank are consistent with the following sequence of events: (1) primary rupture of subject cylinder due to over-pressurization; and (2), forceful impact of the subject valve/ pipe fitting assembly with an external object (i.e., upon tank rupture, the valve/pipe fitting assembly were launched through the air, ultimately colliding with a hard object). Thus, the pipe fitting fracture and damage to the top of the tank are the “victims” of the tank rupture.

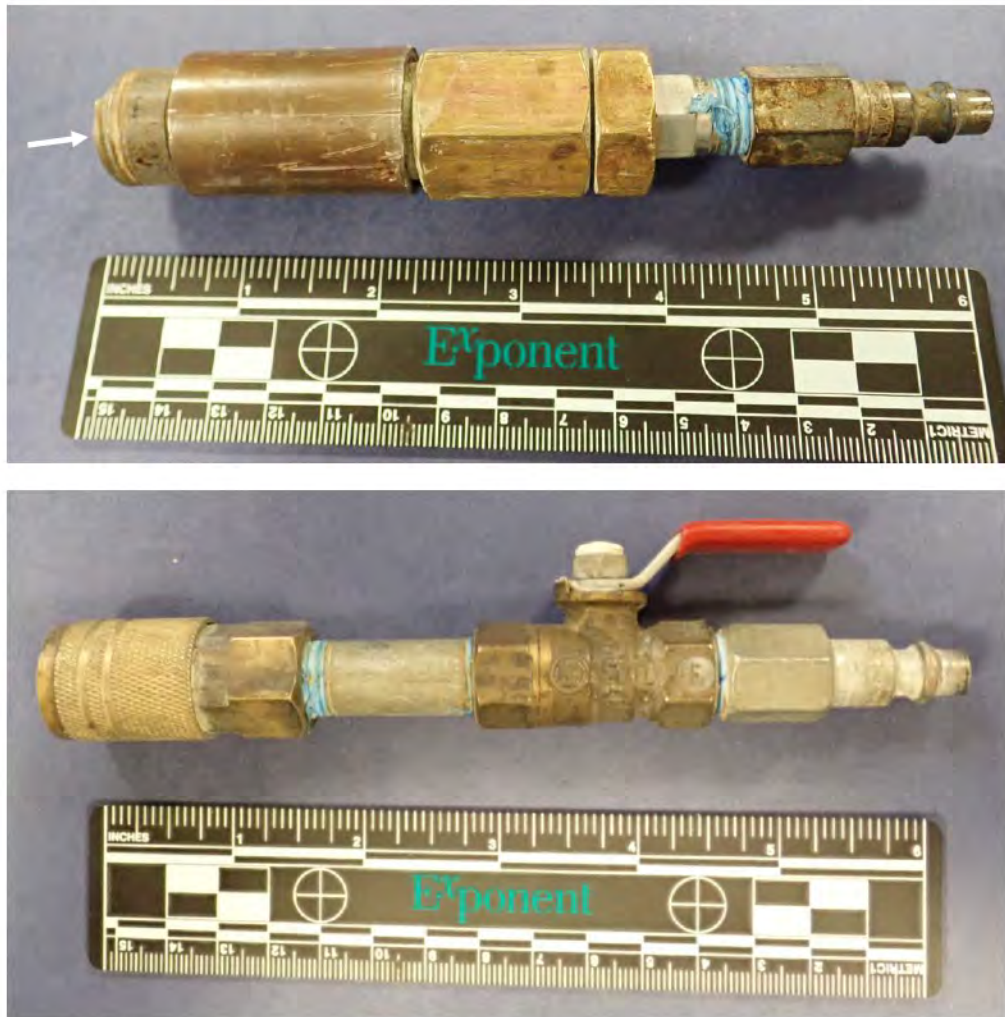
The subject fitting assembly was originally connected to the subject cylinder valve assembly, and is shown in Figure 7. The fitting assembly consisted of two components: a pipe nipple that connected to the accident cylinder valve assembly, and a quarter-turn ball valve component, that connected to the nipple via a brass, quick connect-type pressure fitting. The threaded nipple was threaded into the valve assembly, and fractured at the first non-engaged thread. The location of the fractured threaded end is indicated by an arrow in Figure 7. Photographs of the pipe fitting fracture surface and the remaining, mating fracture surface within the valve assembly are shown in Figure 8.

Figure 7. Photographs of the subject fitting assembly. The arrow indicates the threaded nipple fracture surface.

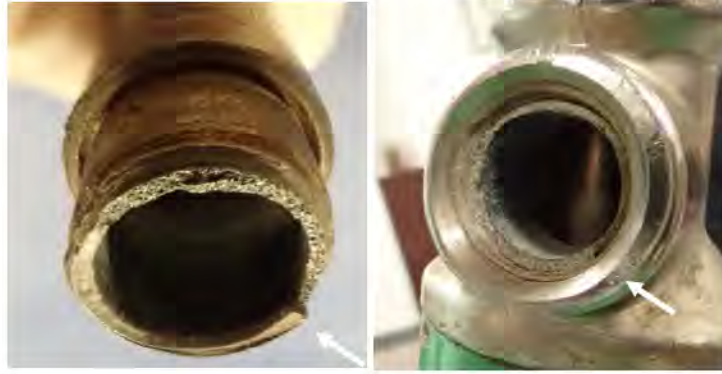
Figure 8. Photographs of the fracture surfaces on the pipe nipple (left) and the mating surface still contained in the cylinder valve assembly (right). The thread “step” is indicated by and arrow in both images.

Both mating threaded pipe nipple fracture surfaces exhibit a matching “step” where the fitting fracture surface is separated by a thread step, as shown by arrows in Figure 8. Due to geometry, when fractures occur in the threaded portion of fasteners/connections, a “step” or skipped thread is typically formed at the final fracture location. Thus, the area opposite the skipped thread is typically near the fracture origin.

As observed in the right-hand image of Figure 8, the skipped thread is present at approximately the 4 o’clock position in the connection to the valve assembly. This indicates that the fracture origin was located at the top half of the valve/fitting assembly, and the final fracture location at the bottom half. This fracture morphology is consistent with the fitting being “bent” downwards direction (as shown in Figure 8). For a bending moment to occur at this location, a force must have been applied to the pipe fitting in approximately the downward direction (toward the center of the cylinder). Loading in this direction is consistent with the inward plastic deformation observed on the cylinder cap itself. This loading condition is schematically depicted in Figure 9.
